The Risk of Arsenic in Drinking Water in Somotillo Municipality, Nicaragua

Bob Thorp, Osler Guillen, Maicol Calderón, Rob Pettigrew

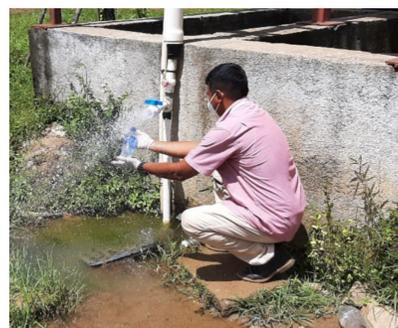
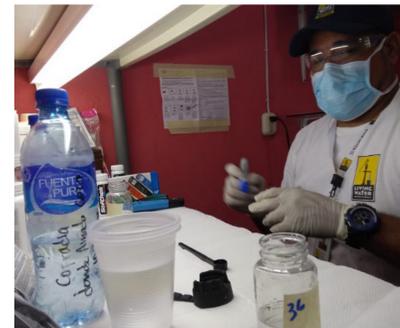
- A total of 42 water points in 20 communities were sampled between February 10-14, 2020
- The sampled water sources included 14 deep drilled wells (≥ 200 feet), 11 shallow drilled wells (< 200 feet), 12 hand-dug wells, 3 rivers, and 2 springs
- Arsenic, pH, turbidity, and Total Dissolved Solids were tested for each water point. Turbidity readings were taken at the water point, but all other parameters were tested at the Living Water Somotillo office. The HACH Arsenic Low Range Test Kit was used to evaluate arsenic concentrations

- Arsenic was identified in 38% (n=16) of the water sources tested
 - Arsenic was detected in seven of the deep drilled wells (50%), three of the shallow drilled wells (27%), three of the hand dug wells (25%), and all three rivers (100%) - no water sample from a spring had detectable arsenic
 - Six of the drilled wells with detectable arsenic were drilled between 200 and 350 feet deep
